**Kineticcorp**<sup>TM</sup>  
Forensic Engineering and Visualization

Case Name: *Bacho v. Rough Country, LLC*

As requested, Kineticcorp investigated and reconstructed a multiple vehicle crash that occurred at approximately 8:06 PM on December 22, 2012. The crash occurred at the intersection of Lower Fayetteville Road and Newnan Crossing Bypass in Newnan, Georgia. A southbound 1999 Chevrolet K1500 pickup truck, driven by Taylor Long, failed to stop at a red light and impacted an eastbound 2012 Toyota Sienna driven by Natalie Bacho. According to the police report and phone records, Mr. Long was on the phone with his girlfriend before and during the accident.

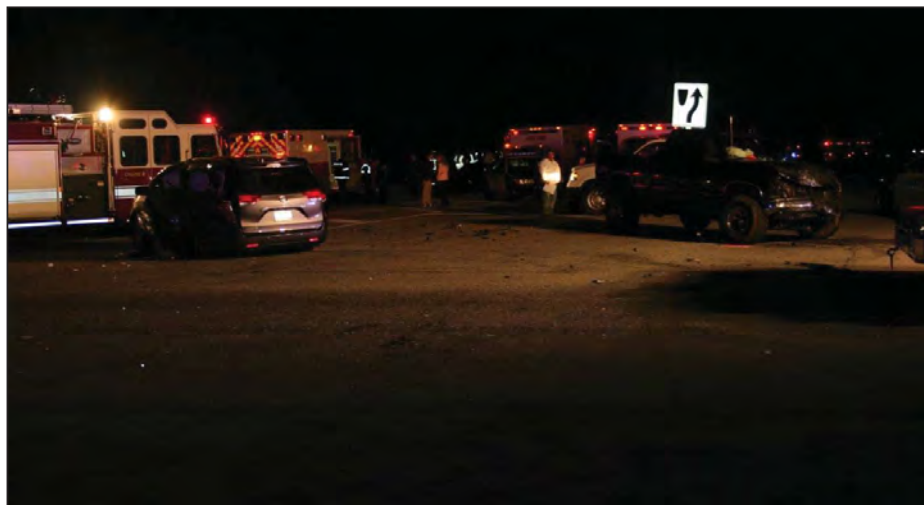
*Figure 2 – Police Photograph of Scene*

In the area of the crash, Newnan Crossing Bypass consists of two through lanes each for northbound and southbound traffic as well as dedicated left and right turn lanes separated by medians and painted gore areas. Lower Fayetteville Road consists of a single travel lane for eastbound and westbound traffic and dedicated turn lanes separated by painted lines. The intersection is controlled by lighted overhead signals. Figure 2, below, is a photograph taken by police on the night of the crash. The photograph was taken facing in the southbound direction of travel of the Chevrolet K1500. As seen in the photograph, the collision occurred in the intersection of these two roads. Mr. Long's Chevrolet K1500, right, and the Toyota Sienna, left, can be seen in Figure 2.

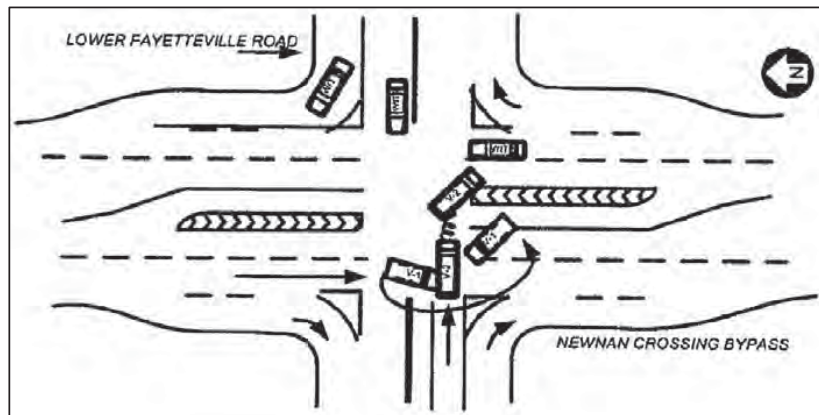
*Figure 4 – Police Scene Diagram*

Figure 4 is a diagram of the scene created by the Georgia Police depicting the layout of the intersecting roadways, the approximate impact configuration and the rest positions of the two vehicles. Kineticorp was also provided with survey data collected by the Georgia Police. Kineticorp incorporated the police measurements in the creation of the computer scene model.

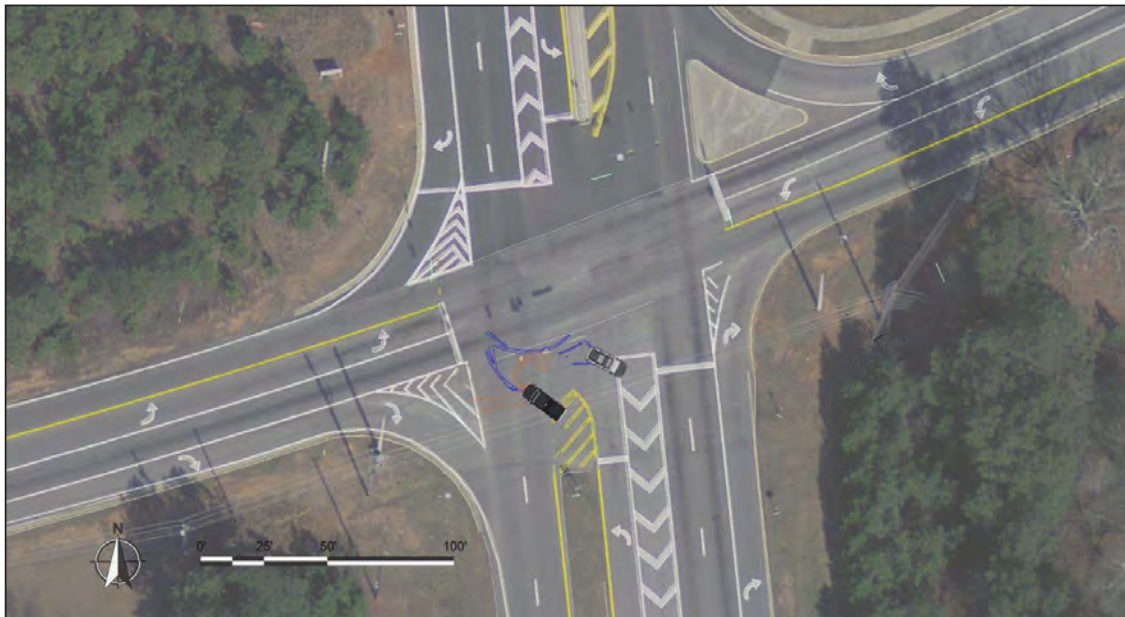
*Figure 7 – Scene Diagram*

Figure 7 is a graphic containing a top down view of the completed scene model including the points of rest for the two vehicles and the other physical evidence. As seen in Figure 7 the alignment of the roads at the intersection results in an oblique approach angle and the roadways are not oriented along the cardinal directions.

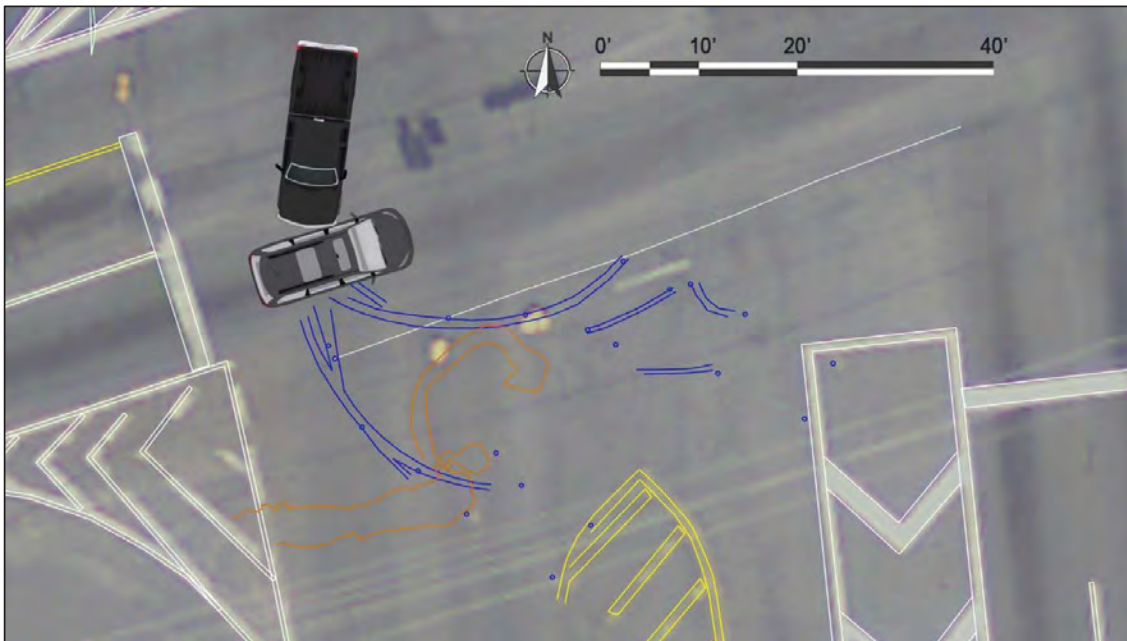
*Figure 18 – First Contact Positions*

Based on the reconstruction of the physical evidence on the roadway and the damage patterns sustained by each vehicle, Kineticorp was able to reconstruct the configuration of the vehicles at impact and the motion of the vehicles during the accident sequence to their points of rest. Figure 18 and 19 each contain two top down views of the scene model showing the approximate positions of the vehicles during the accident sequence. Figure 18 shows the vehicles at their point of first contact.

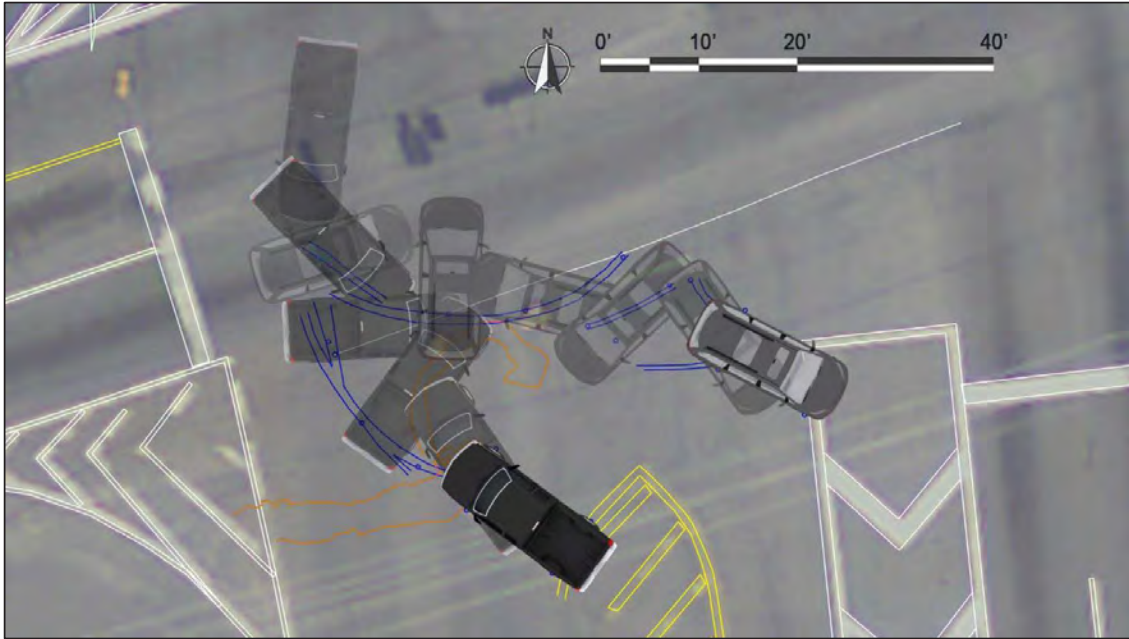
*Figure 19 – Accident Sequence*

Figure 19 shows the accident sequence including the intermediate positions following the tire mark, gouge and fluid evidence and showing the motion of the vehicles to their known points of rest.

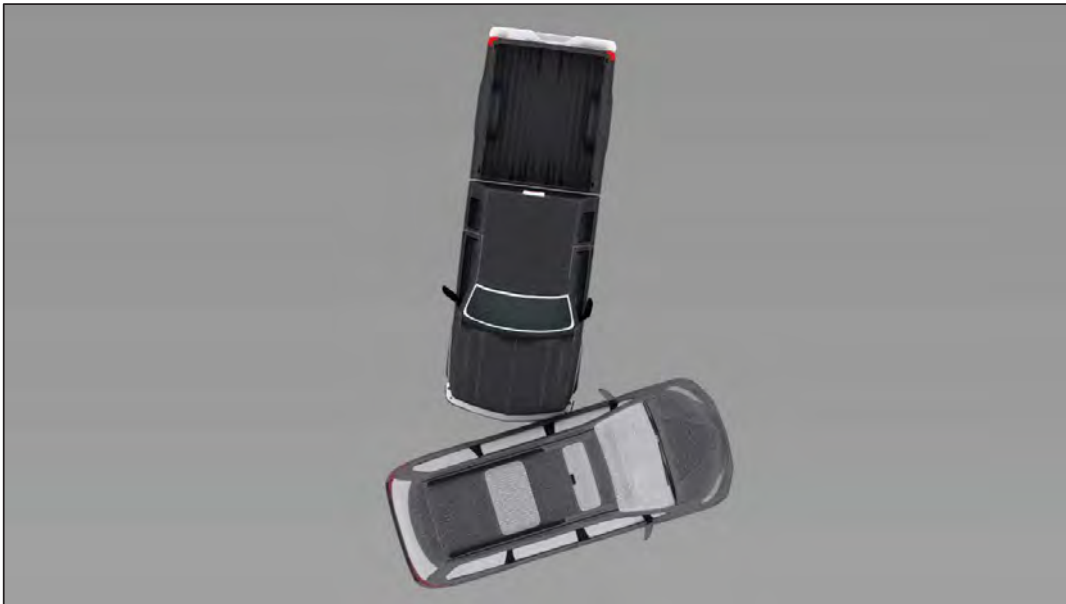
*Figure 20 – Impact Configuration*

Figure 20 is a graphic depicting the impact configuration between the Toyota and Chevrolet.

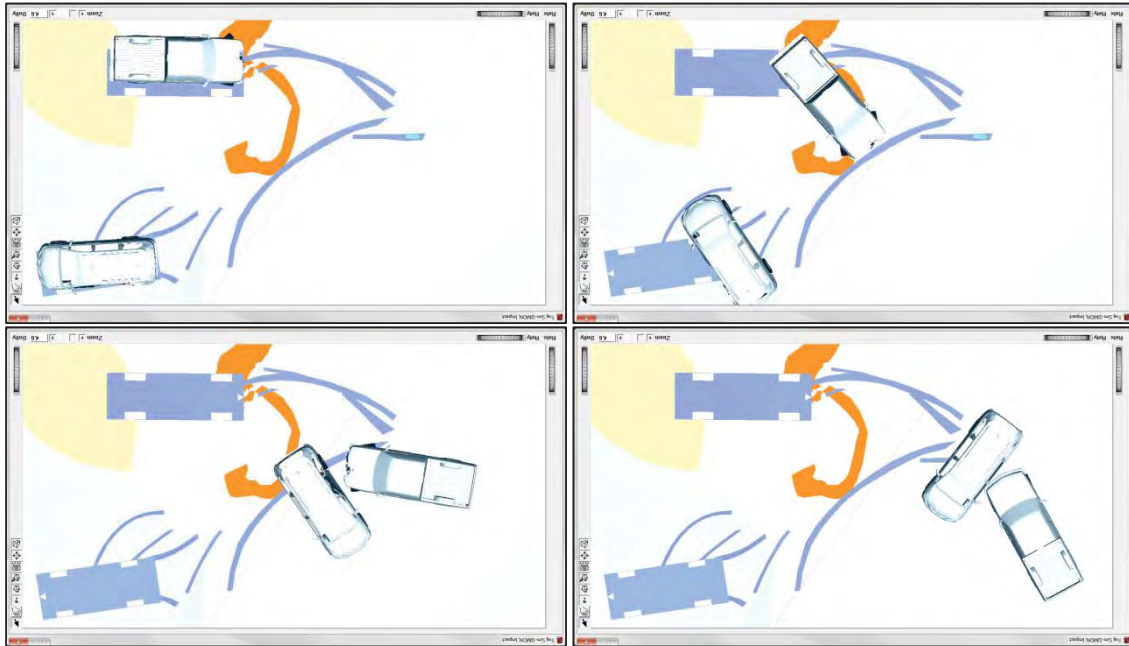
Figure 21 – HVE-3D Simulation Sequence

The results from the CoE/CoM analysis are as follows. The Chevrolet, driven by Taylor Long was initially traveling southbound when it failed to stop for the red light and impacted the Toyota on its left side. The Chevrolet's speed at impact was approximately 39 mph. The Chevrolet was redirected to the southeast while rotating approximately 180 degrees counterclockwise. The Chevrolet traveled approximately 42 feet from the area of impact on the roadway to rest near the center median. Kineticorp determined that the left front wheel of the Chevrolet was seriously damaged during the impact. Kineticorp calculated the post-impact speed of the Chevrolet to be approximately 20 mph. The change in velocity experienced by the Chevrolet, as a result of being redirected by the collision, was approximately 21 mph.

The Toyota was initially traveling 35 mph headed northeast. The impact of the Chevrolet caused the Toyota to be redirected to the southeast where it continued to travel approximately 46 feet rotating counterclockwise approximately 360 degrees before coming to rest. The post-impact speed of the Toyota was approximately 26 mph. The Toyota, as a result of the collision experienced a change in velocity of approximately 20 mph.

KinetiCorp used HVE-3D to conduct an analysis of the impact and subsequent motion to rest of the two vehicles in this accident. HVE-3D uses physics-based impact and vehicle dynamics models. KinetiCorp followed the roadway evidence and resulted in close agreement with the known orientation and points of input vehicle and scene geometry, physical attributes, and driver control inputs. The resulting simulation followed the roadway evidence and resulted in close agreement with the known orientation and points of rest of the two vehicles. Our simulations utilized inputs for the vehicles, the roadway, the steering, acceleration, and braking control inputs by each driver that were physically realistic, reasonable and justified by the available technical literature of accident reconstruction. Figure 21 is a series of top down view images showing the progression of the vehicles in the accident simulation from impact to rest.

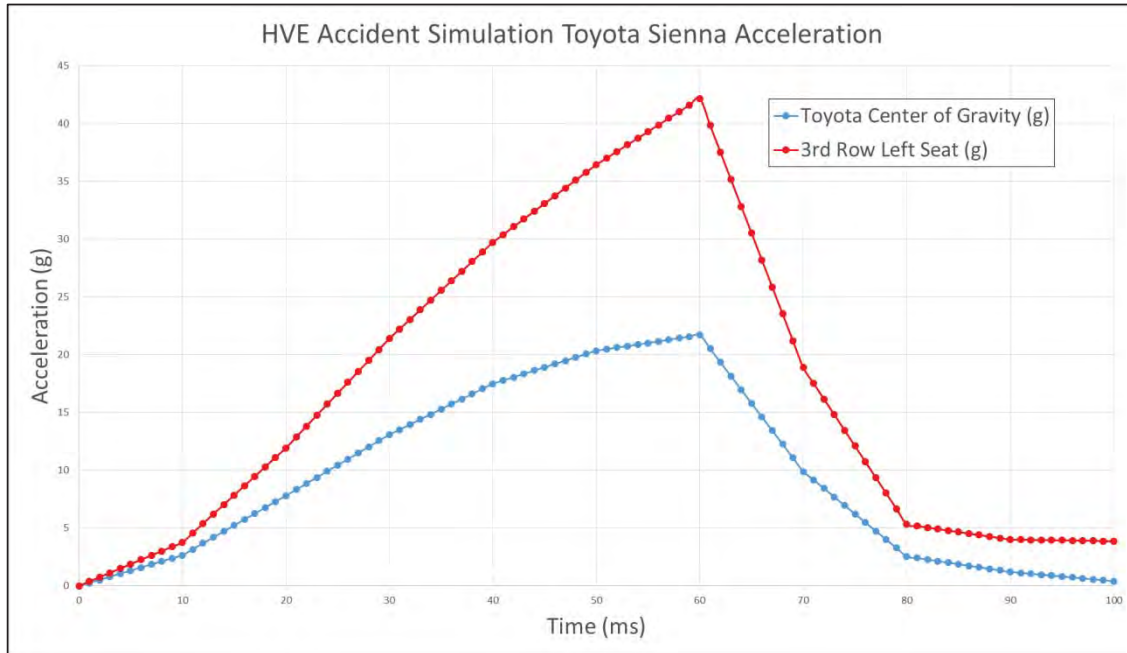
Figure 21 – HVE-3D Accident Acceleration Plots

approximately 42 times gravity during the impact<sup>2</sup>. Figure 22 is a plot of the total acceleration experienced during the first 100 milliseconds in the HVE simulation for the vehicle's center of gravity and the third row left seated position.

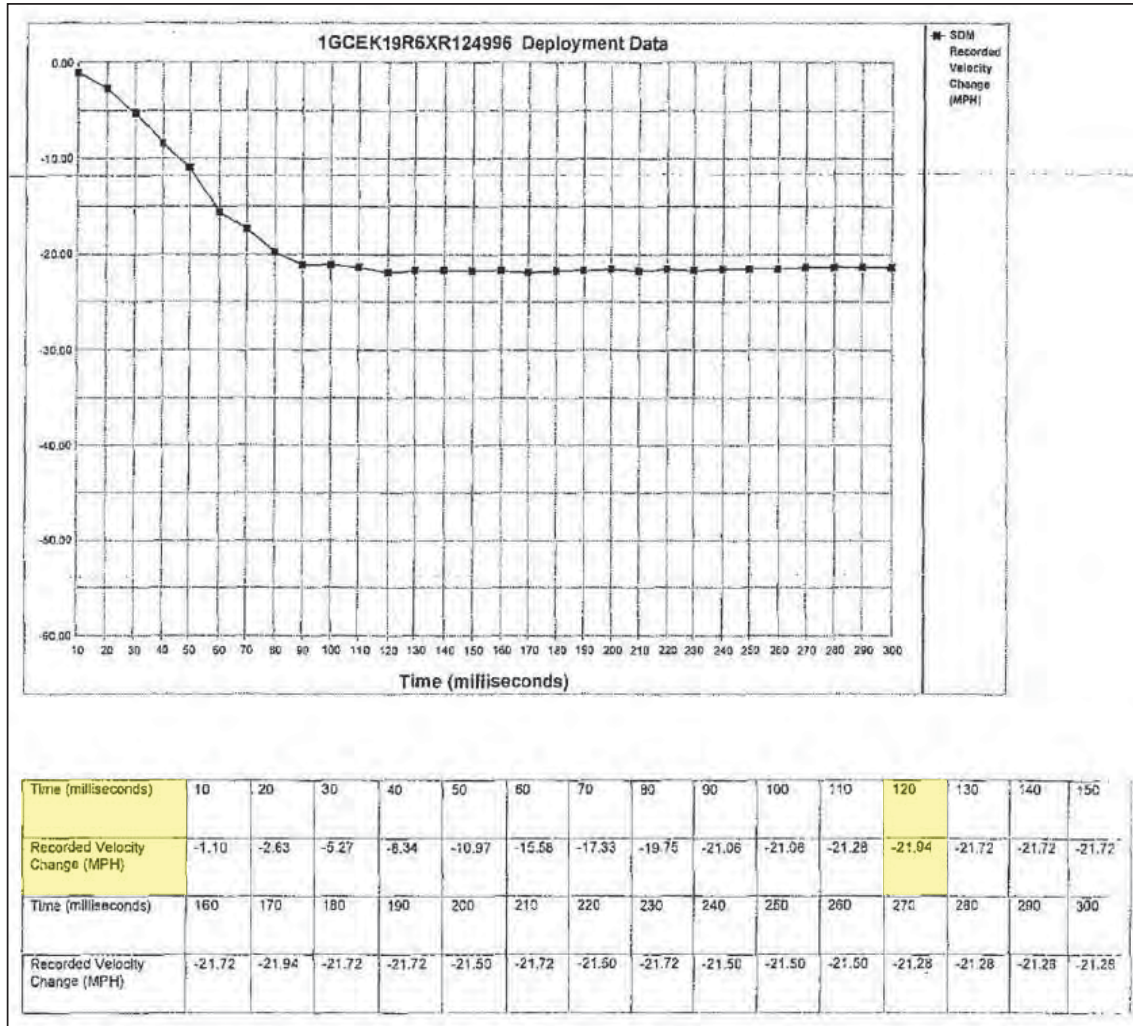
Table 2 – Chevrolet ACM Deployment Data

The 1999 Chevrolet K1500 was equipped with an Airbag Control Module (ACM) capable of recording data related to the deployment of airbags as a result of the crash. Table 2 displays the crash pulse and the recorded velocity change in miles per hour. The maximum change in velocity, or delta-V, experienced by the K1500 is 21.94 mph at 120 milliseconds although the delta-V plateaus around 100 milliseconds.

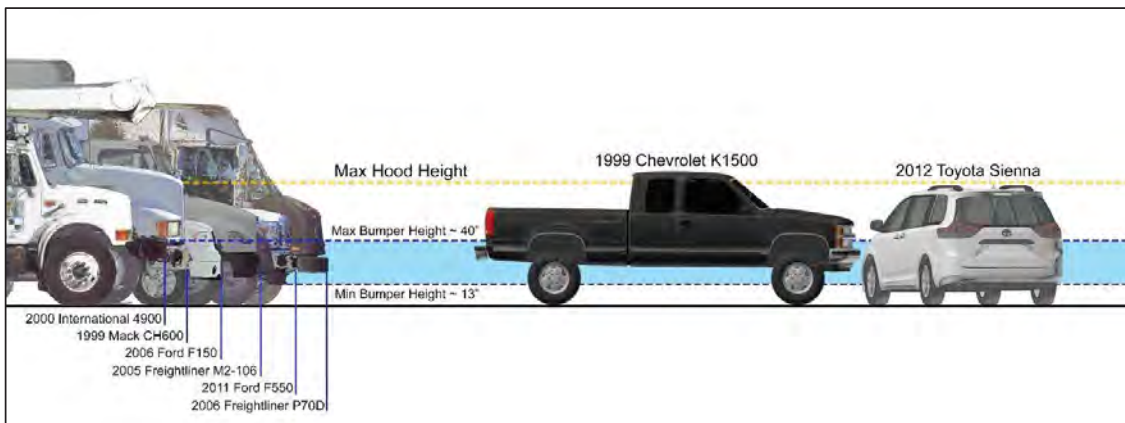
Figure 26 – Bumper Height Comparison

Figure 26 compares the bumper height from the vehicles shown in Figure 25 to the geometry of the vehicles involved in this crash. As shown in the graphic, the bumper of the lifted Chevrolet pickup truck falls within the range of bumper heights of other vehicles one might encounter on public roadways.

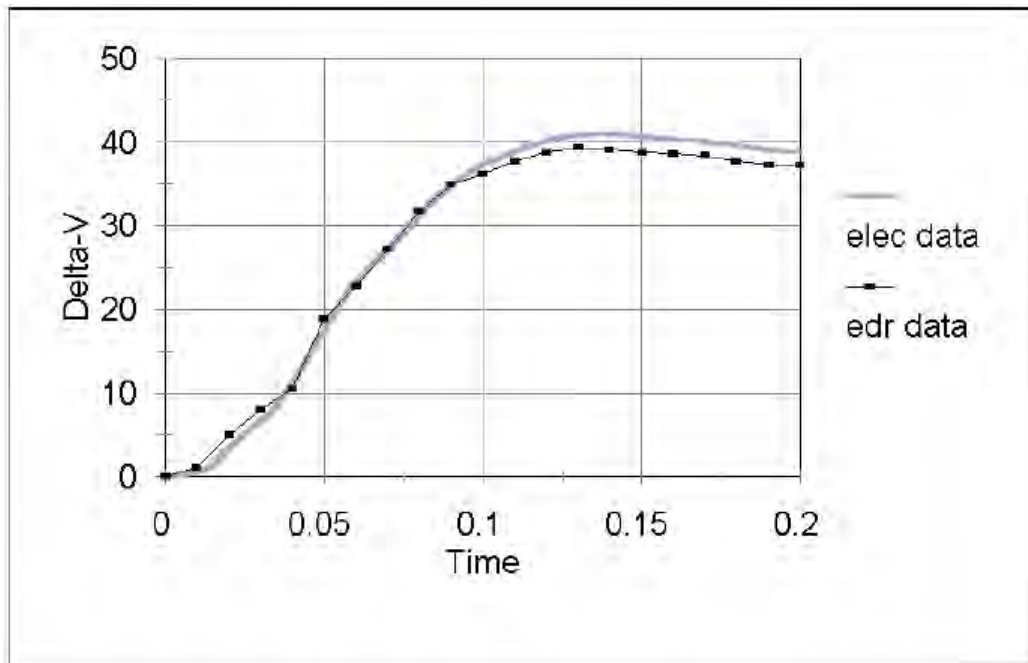
Figure 27 – Published Validation of General Motors Event Data Recorders

Accident Reconstruction: On page 29 of his report, Dr. Renfroe summarized his reconstruction of the accident using the PC-Crash simulation program. Dr. Renfroe's simulation resulted in the Chevrolet experiencing a  $\Delta V$  of approximately 17 mph. However, the subject Chevrolet was equipped with accelerometers integrated into the airbag system that sensed and recorded the accelerations experienced by the Chevrolet during the subject crash. This data was recovered by the Crash Data Retrieval (CDR) software and reported a maximum velocity change for the Chevrolet of approximately 22 mph. Dr. Renfroe reported that this data was among the materials he received (page 7 of his report) and on pages 57 and 58 of his deposition Dr. Renfroe states that he matched his reconstruction to the CDR data from the accident. Dr. Renfroe's PC-Crash simulation underestimated the speed change experienced by the Chevrolet by 5 mph, or 23%, when compared to the accelerometer data recorded by the subject vehicle. Numerous studies have been published pertaining to the accuracy of this accelerometer data for use in accident reconstruction. One such study<sup>3</sup>, authored by researchers from the National Highway Traffic Safety Administration, examined the accuracy of model year 1998 General Motors cars, SUVs and pickup trucks similar to the subject Chevrolet pickup truck. Figure 27 is a figure from this study. As seen in the figure, the laboratory  $\Delta V$  (labeled 'elec data') is plotted in blue and the data from the event data recorder (labeled 'edr data') is plotted as black data points. This study found that the data from the airbag accelerometers generally corresponded to laboratory instrumentation, however the EDR data from the airbag accelerometers was slightly lower than the laboratory instrumentation, as seen in the figure.

This testing shows that the Chevrolet  $\Delta V$  of approximately 22 mph would be slightly lower than the actual  $\Delta V$  from the crash. Dr. Renfroe's analysis is opposite of these findings, the  $\Delta V$  reported by the CDR system is 23% higher than the results of Dr. Renfroe's PC-Crash simulation.

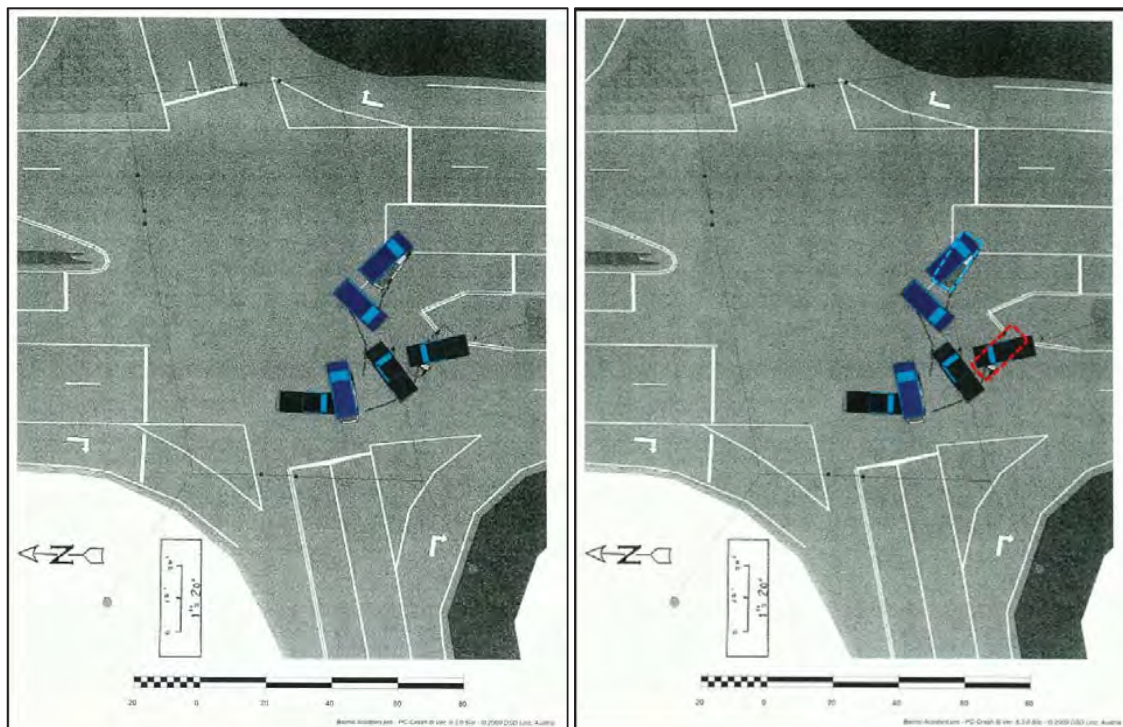
Figure 28 – Dr. Renfroe's PC-Crash Simulation

Kineticorp has reviewed the output from Dr. Renfroe's PC-Crash simulation, which is shown below in Figure 28. The image on the left of the figure is the original PC-Crash output and the image on the right contains a blue dotted line that represents the rest position of the Toyota and the red dotted line represents the rest position of the Chevrolet. As seen in the diagram, the PC-Crash simulation does not match the physical evidence, specifically orientations of both vehicles at their points of rest. As a result, the simulation underestimates the post-impact rotational movement of both vehicles. Kineticorp believes that the simulation underreports the energy of the subject accident and explains why the  $\Delta V$ s from the simulation are approximately 23% less than the  $\Delta V$  from analysis the airbag accelerometer data.

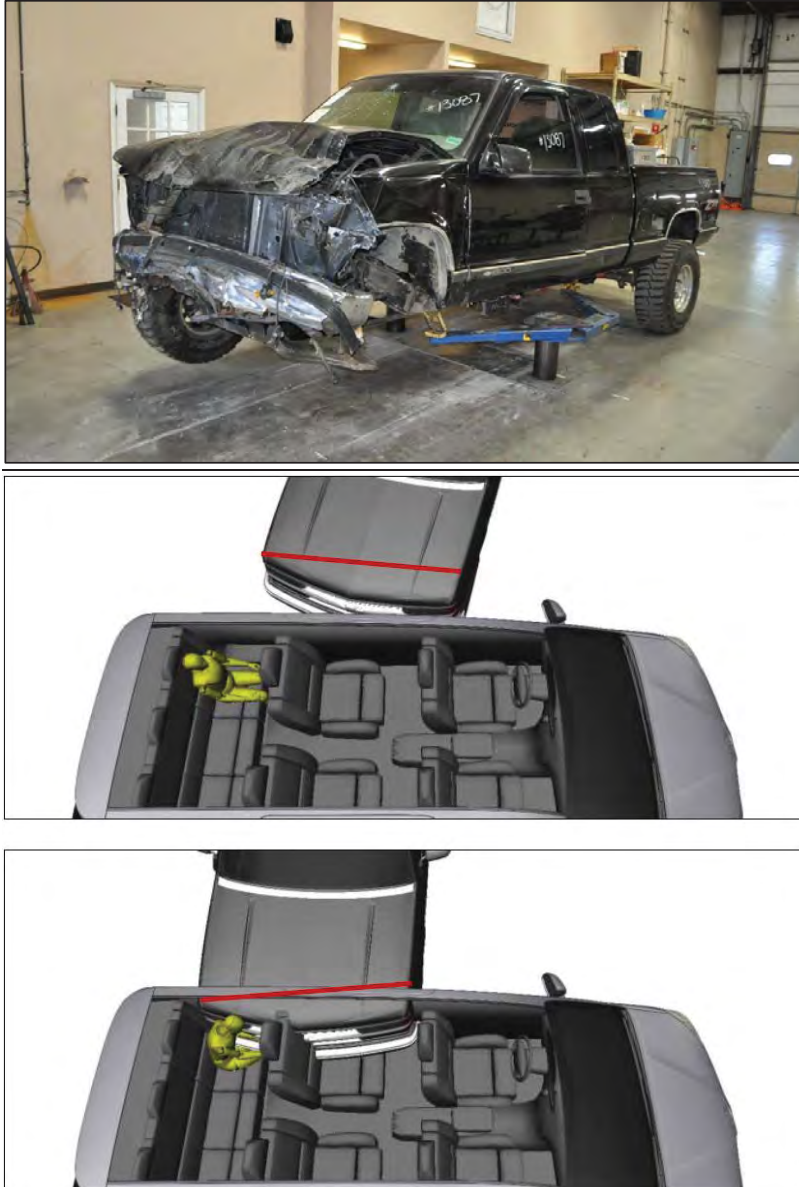
*Figure 29 – Dr. Renfroe's Intrusion Graphic*

Page 39 of Dr. Renfroe's report contains graphics depicting the interaction between the two vehicles in this crash. Figure 29 contains a photograph of the front of the Chevrolet and Dr. Renfroe's graphics. As seen in Dr. Renfroe's graphics, the impacting Chevrolet is depicted in an undamaged state. The Chevrolet experienced over 12 inches of rearward crush deformation on its left side as a result of the impact. The damage can be seen clearly in the photograph. By depicting an undamaged Chevrolet, Dr. Renfroe is graphically demonstrating a scenario that is not representative of the physical evidence. This graphic is inaccurate and misleading when illustrating the intrusion of the Chevrolet into the Toyota. Additionally, Dr. Renfroe's graphic does not depict any deformation to interior panels of the Toyota, making this graphic inconsistent with Result #3 from page 43 of his report.

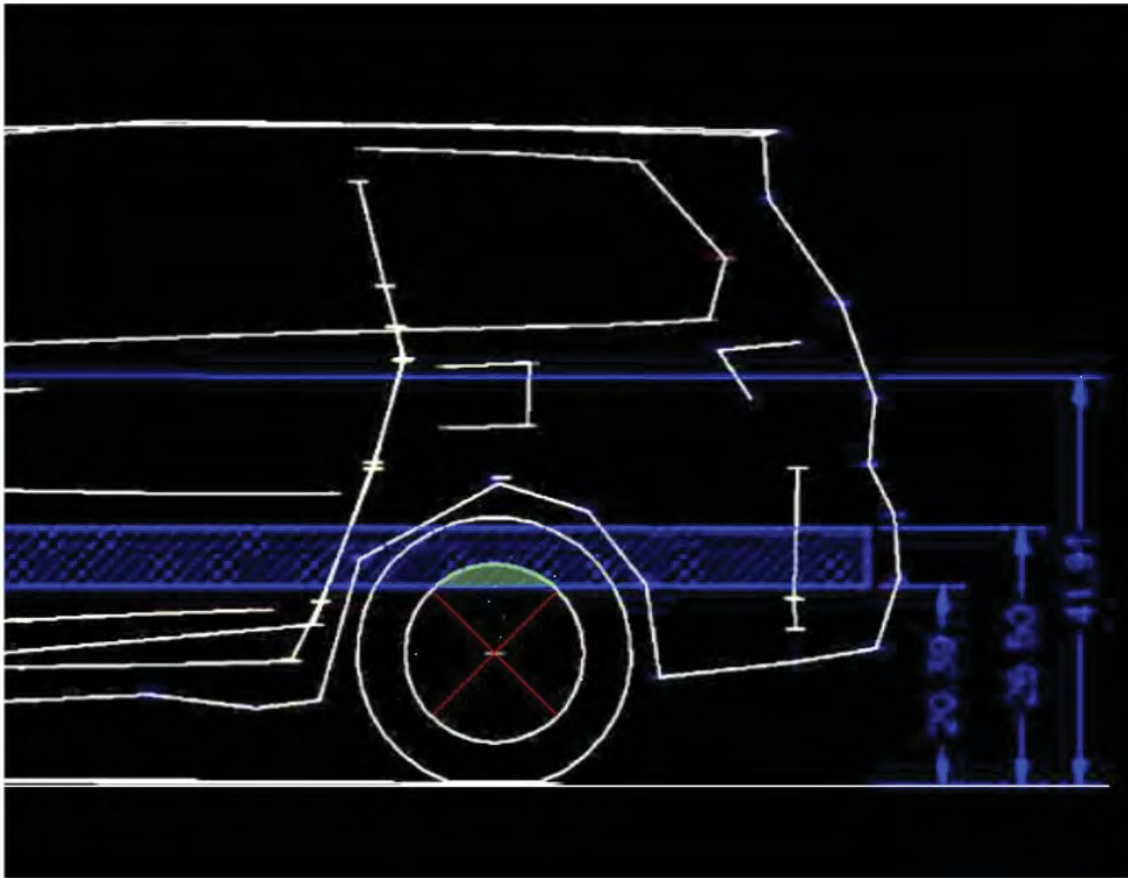
*Figure 30 – Dr. Renfroe's Figure Representing Vehicle Compatibility*

Vehicle Compatibility: Figure 30 is a figure from Dr. Renfroe's report. In this figure, a computer model of the driver's side of the Toyota is shown, along with a blue shaded rectangle that represents the area of the Toyota that would be struck by the bumper of a stock Chevrolet in a side impact. In his report, Dr. Renfroe argues that the engagement between the bumper of the Chevrolet and the rear wheel of the Toyota would prevent intrusion into the side of the Toyota. During his deposition (page 76), Dr. Renfroe testified that the area of the Toyota wheel engaged by the bumper of the un-lifted stock Chevrolet pickup was 25%. His drawing below shows the area he claims is 25%, colored in green. Red lines have also been added to Dr. Renfroe's graphic to divide the wheel into quarters. Kineticorp took measurements from Dr. Renfroe's computer model and determined that the area of the Toyota wheel is approximately 270 square-inches. The area where the Chevrolet bumper would contact the wheel is less than 21 square-inches amounting to less than 8% of the total area of the wheel. Kineticorp does not believe that this minimal contact between the Chevrolet bumper and a small portion of the aluminum alloy left rear wheel of the Toyota would prevent or even significantly change the intrusion into the side structure of the Toyota.

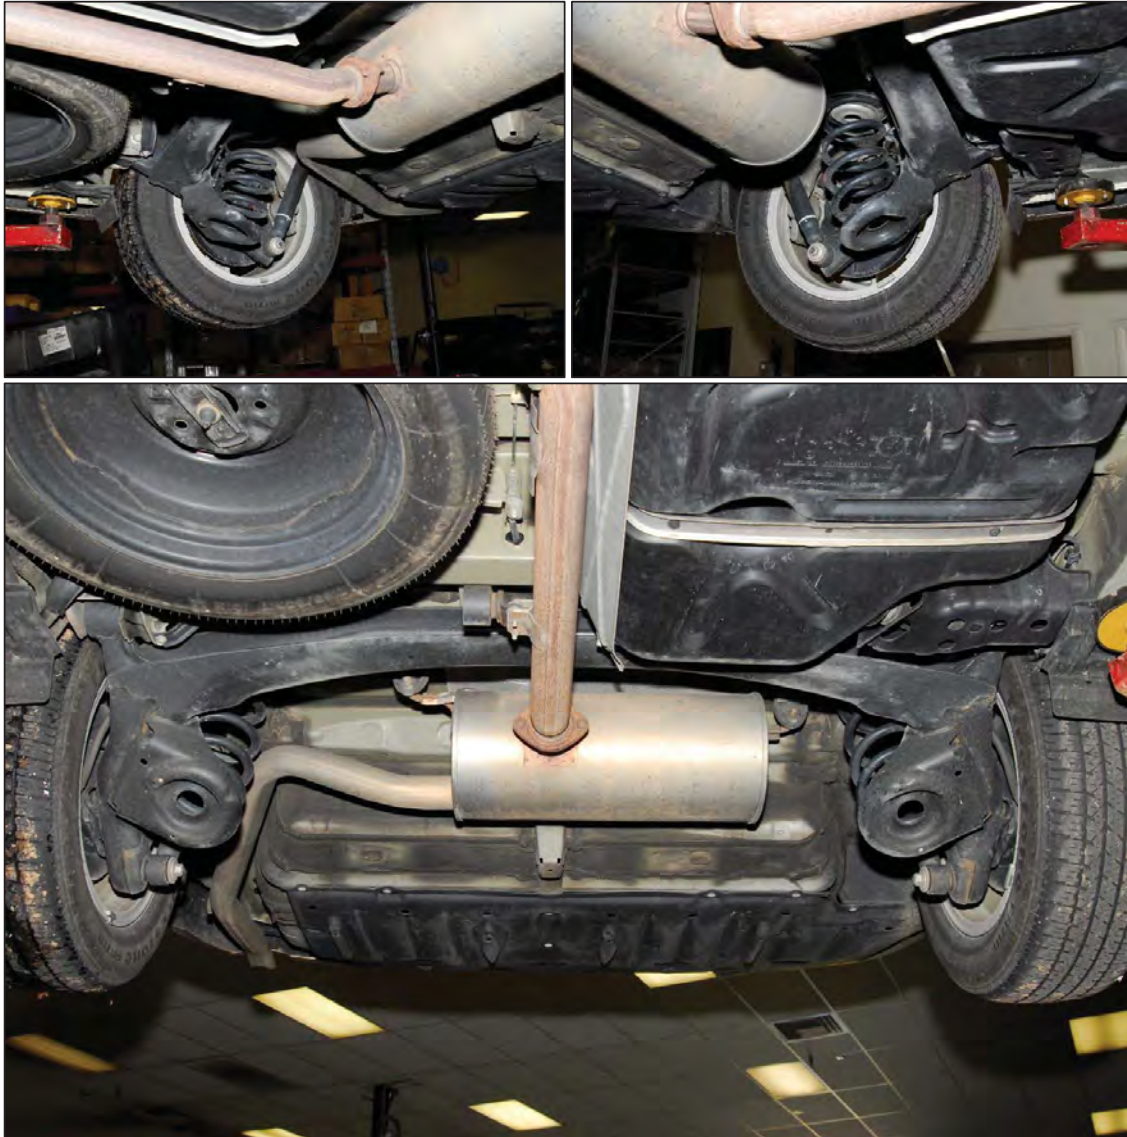
*Figure 31 – Dr. Renfrope's Exemplar FWD Toyota Sienna Photographs*

To support his allegation that engagement between the bumper of the Chevrolet and the wheel of the Toyota would prevent intrusion into the Toyota, Dr. Renfrope opines that the rear drive axle and differential of the Toyota would stiffen and provide structural reinforcement to the wheel during an impact (deposition pages 84-85). The Bacho Toyota was not an all-wheel drive model and was not equipped with a rear drive axle or rear differential. According to the Toyota inventory vehicle detail sheet obtained by Kineticorp, the Bacho Toyota Sienna was the two-wheel, front-wheel drive (FWD) model. The exemplar Toyota Sienna inspected by Dr. Renfrope and his staff was also the front-wheel drive model. Figure 31 below contains photographs from Dr. Renfrope's file and clearly shows no rear drive axle or differential in the rear of the Toyota. Dr. Renfrope's opinion that the rear axle and differential would stiffen the rear wheel of the Toyota does not apply to this crash.

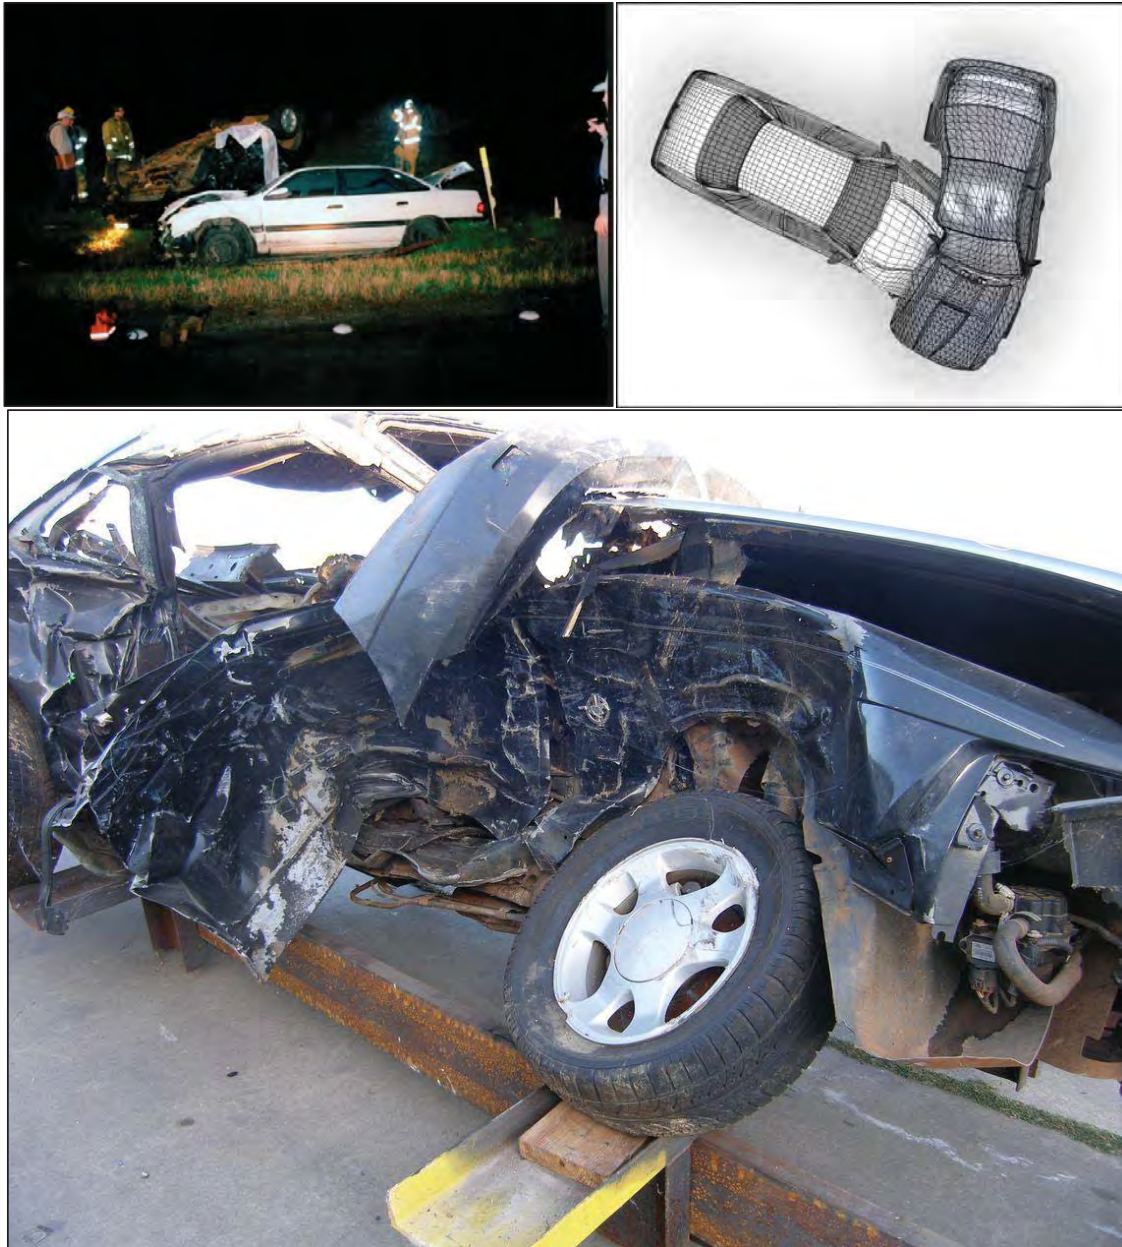
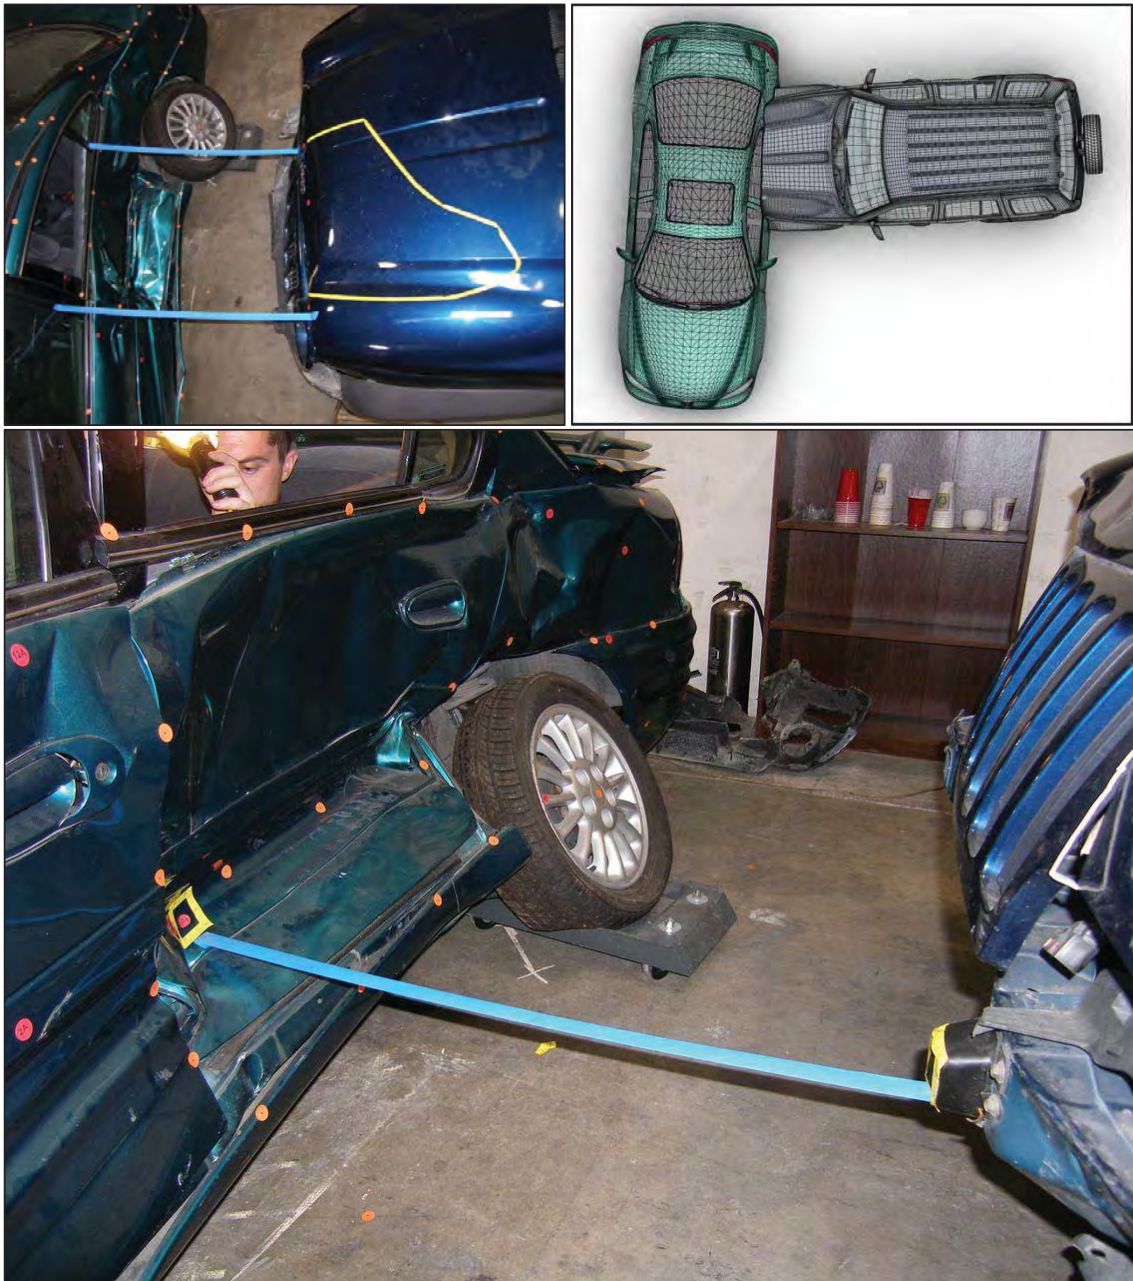
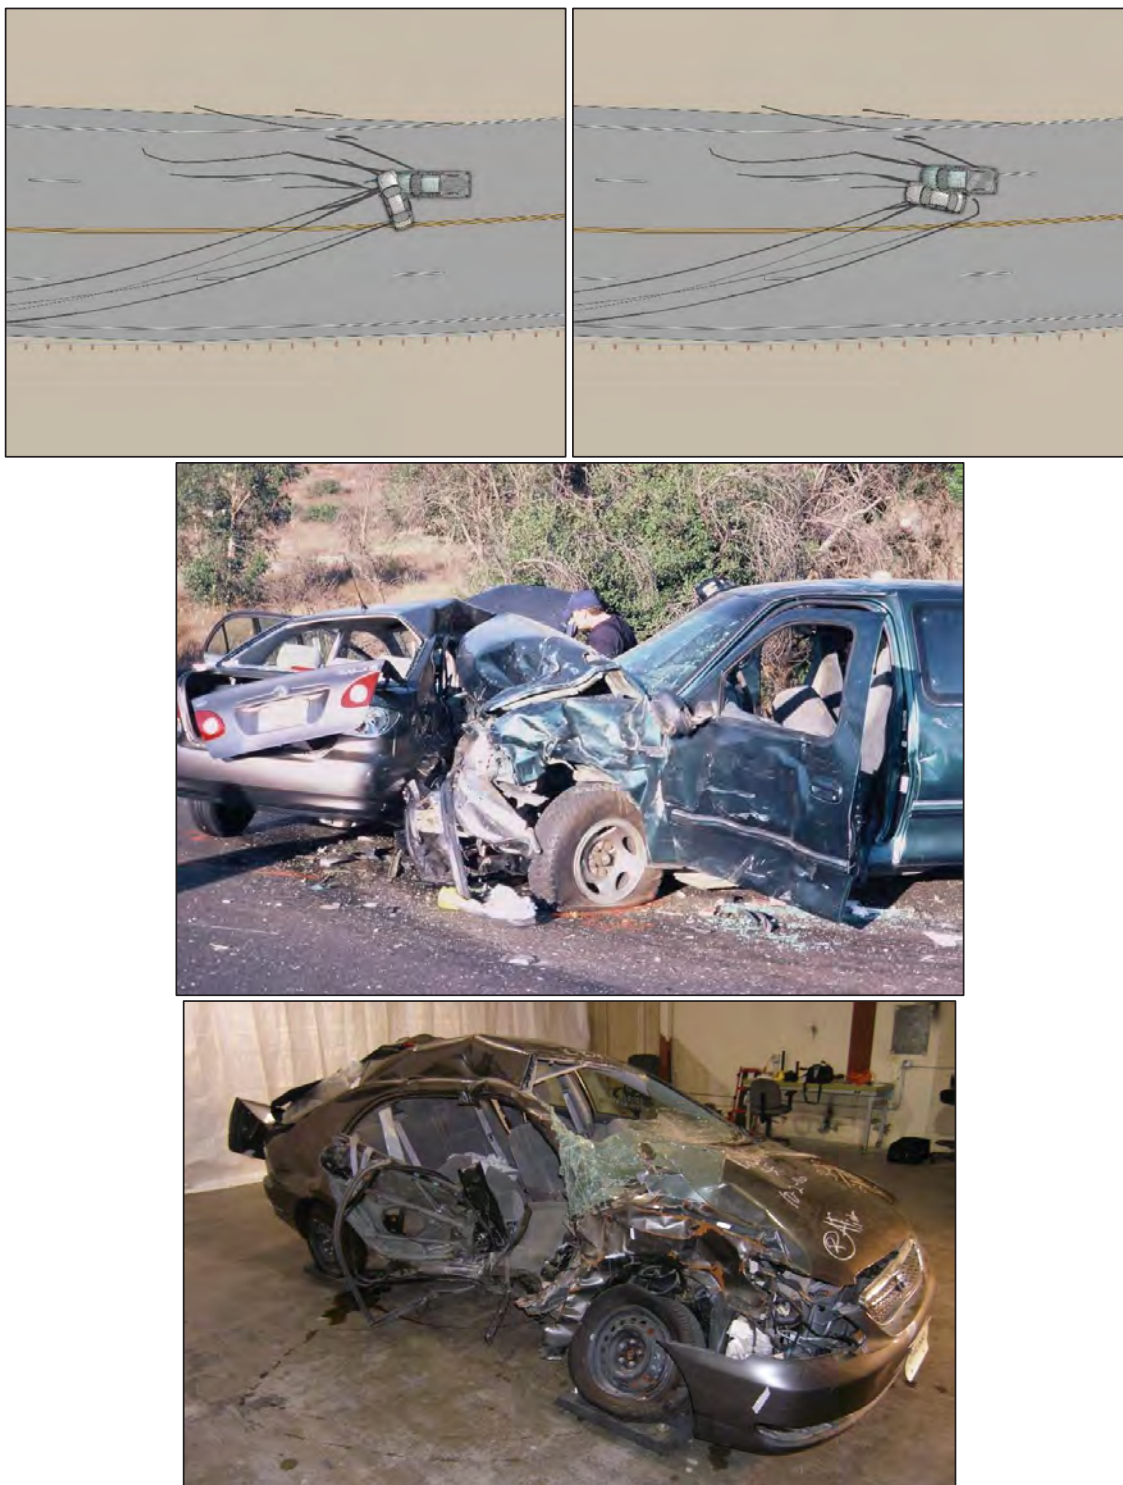
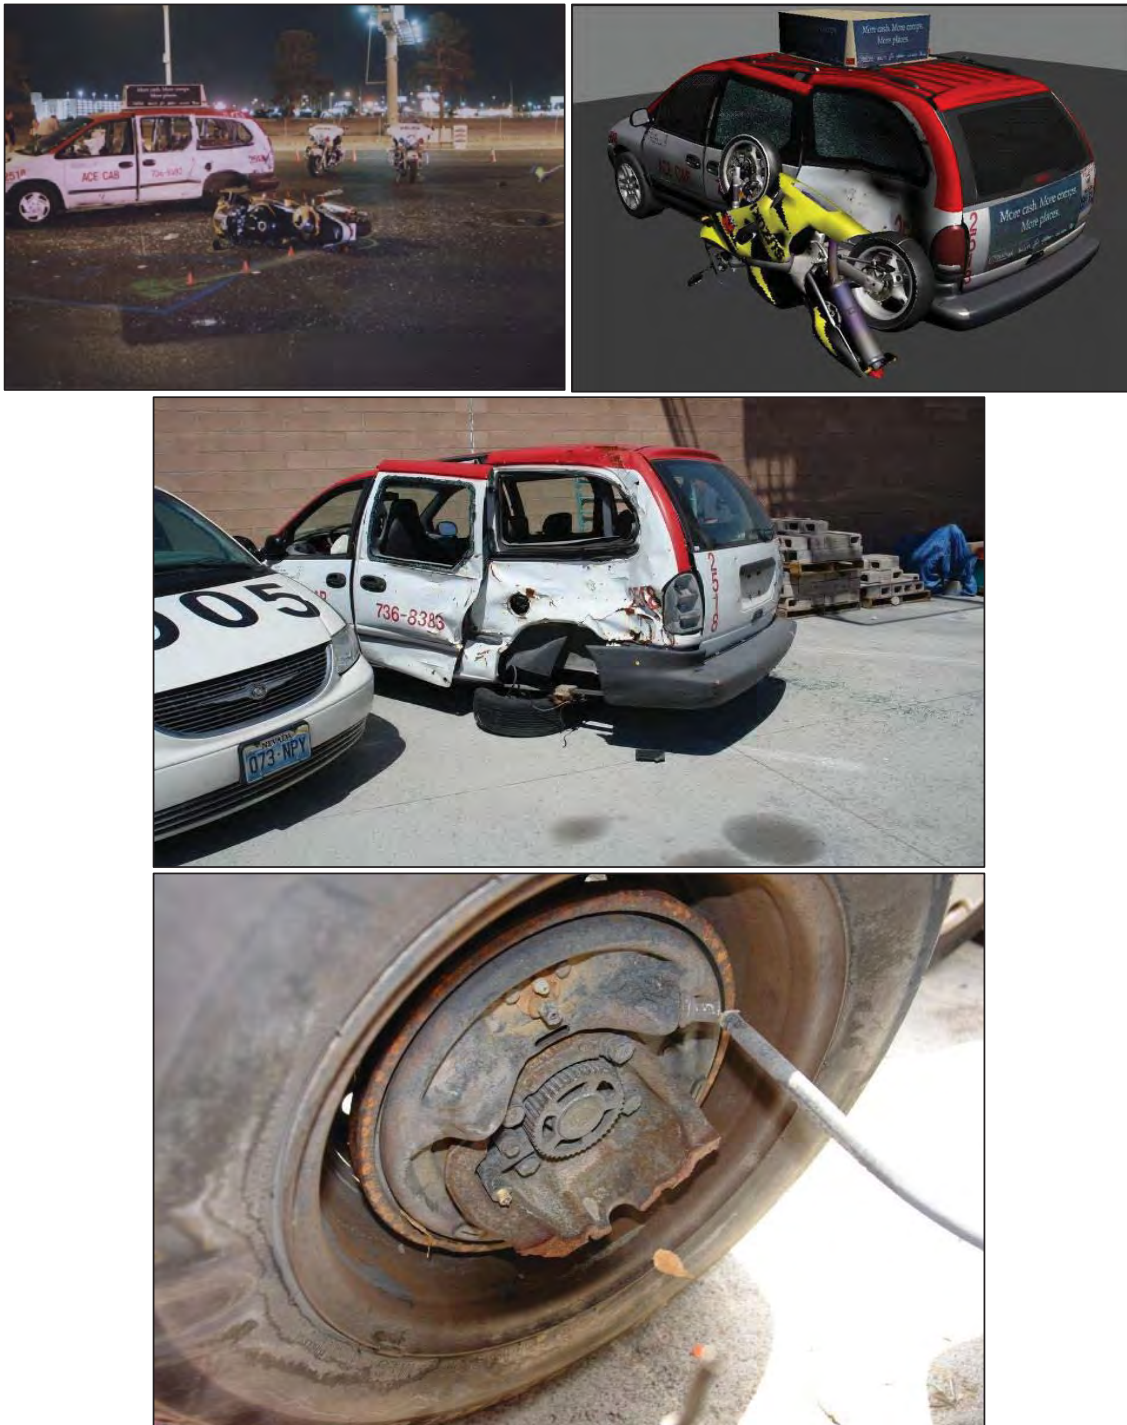
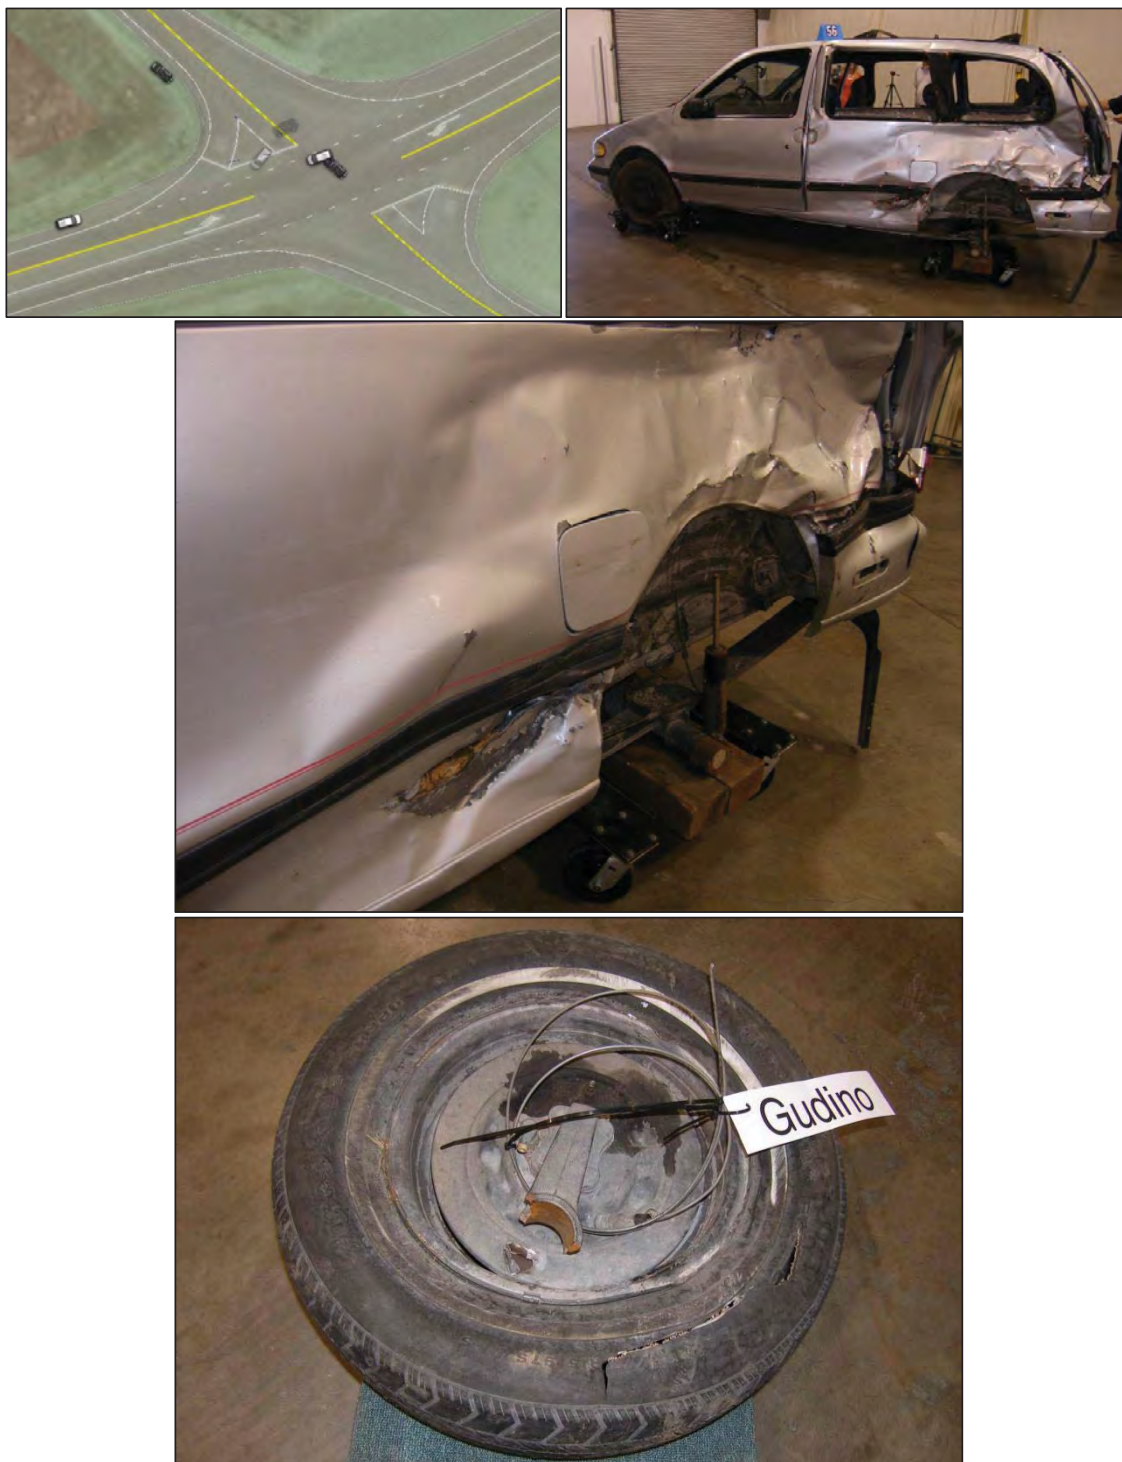
On pages 90 and 91 of his deposition, Dr. Renfro testified that he has not seen a side impact where there was a contact at the wheel where there was intrusion into the occupant space. Kineticcorp engineers have reconstructed thousands of vehicle accidents, many of which were vehicle-to-vehicle crashes. Kineticcorp routinely reconstructs side impacts in which a wheel of the struck vehicle was engaged, deformed and/or broken, and the struck vehicle experienced significant intrusion. Of these crashes, some involved impacts into the left rear wheel of mini-vans in which that wheel was broken from the vehicle and the minivan experienced intrusion into the rear occupant compartment of the vehicle. Figures 32a – 32e below contain examples of these crashes.
